Pump and Mixer Specialists

Location: **City of Anywhere**
 Date: **December 1, 2009**

Area:	General
Equipment:	Raw Sewage Pump 1

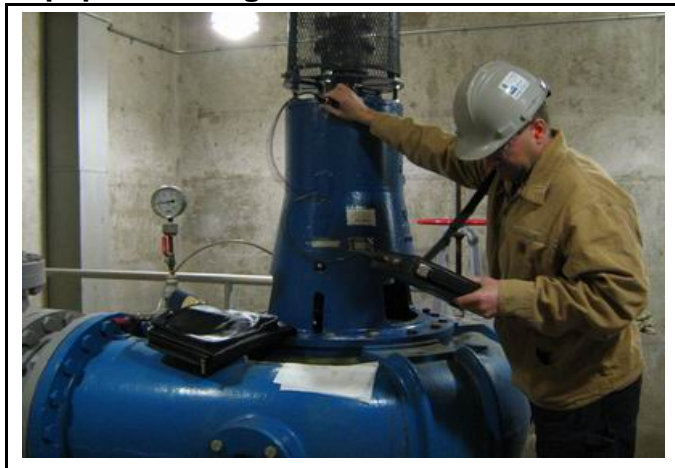
Raw Sewage Pump 1

Vibration on this unit is low and acceptable.

There are no mechanical faults on this equipment.

Packing	OK
Packing Temp.	OK
Flush Plan	OK
Mach Guards	OK
Pressure	106 kpa

Parameters	Values
Vibration (ips)	0.05 ips
Vibration (g's)	0.5 g
Temperature	No issues
Operating Speed	524 rpm

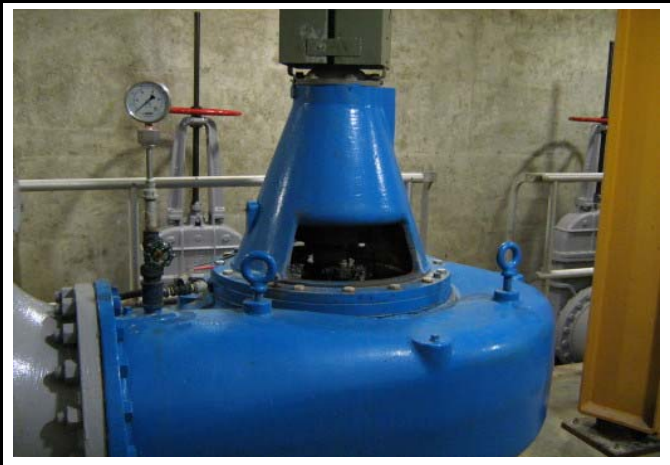
Raw Sewage Pump 3

Vibration on this unit is low and acceptable.

There are no mechanical faults on this equipment.

Packing	OK
Packing Temp.	OK
Flush Plan	OK
Mach Guards	OK
Pressure	100 kpa

Parameters	Values
Vibration (ips)	0.09 ips
Vibration (g's)	0.6 g
Temperature	No issues
Operating Speed	515 rpm

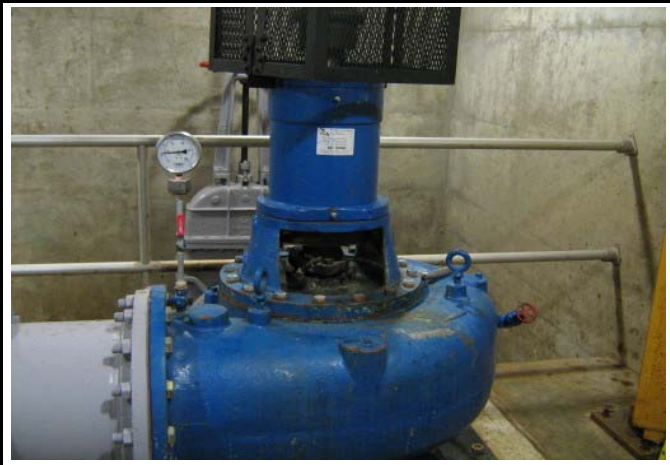
Raw Sewage Pump 4

Vibration on this unit is low and acceptable.

There are no mechanical faults on this equipment.

Packing	OK
Packing Temp.	OK
Flush Plan	OK
Mach Guards	OK
Pressure	112 kpa

Parameters	Values
Vibration (ips)	0.06 ips
Vibration (g's)	0.1 g
Temperature	No issues
Operating Speed	694 rpm

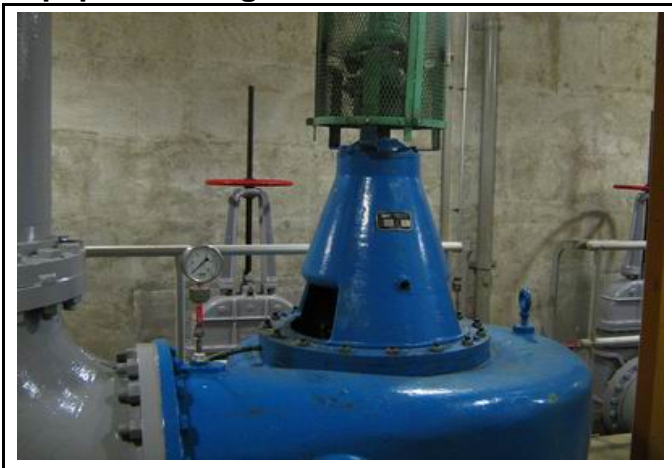
Raw Sewage Pump Diesel

Repair Priority	Developing Problem
Fault Type	Pump Bearing

Vibration on this unit is quite low however the pattern on the pump indicates non-synchronous energy likely related to a dry bearing or early stage bearing fault. Please insure this pump's bearing are adequately lubricated prior to next visit.

Packing	OK
Packing Temp.	OK
Flush Plan	NA
Mach Guards	OK
Pressure	100 kpa

Parameters	Values
Vibration (ips)	0.08 ips
Vibration (g's)	0.7 g
Temperature	Not run long enough
Operating Speed	457 rpm
