STRAY VOLTAGE OR STRAY CURRENTS

Jeff Johnson, ASL Roteq Ltd.

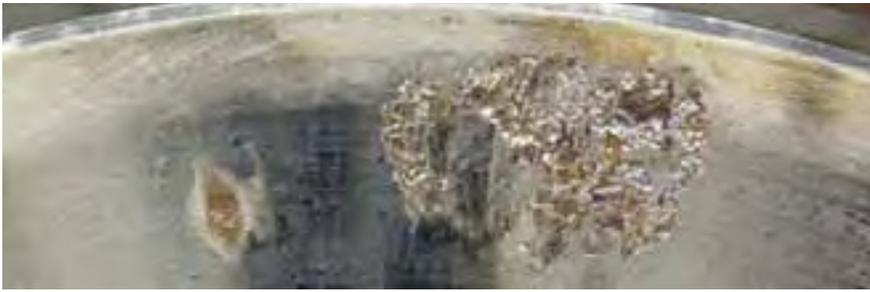
Figure 1: Damage caused by bearing failure

Several years ago, I was involved in a problem, occurring at the City of Peterborough WPCP, where a particular problem, occurring had experienced several failures over its short life. The pump was removed from site, brought back to our service centre, dismantled and inspected. The cause of failure was obviously the bearing, as shown in Figure 1.

The damage in Figure 1 appeared to be a typical bearing overload failure, which can be caused by lack of lubrication, overloading, or other typical mechanical problems. Everyone involved in the dismantle was confident this was the cause of failure. Due to the catastrophic nature of these types of failures, the root cause is often difficult to identify.

I suspect many failed bearings such as the one in Figure 1 are simply discarded and replaced. The pump or motor is put back into service with no knowledge of the root cause. If the pump fails every year, or two or three, it could easily be missed as a systemic problem. Without some form of failure analysis, the root cause of the problem may never be known.

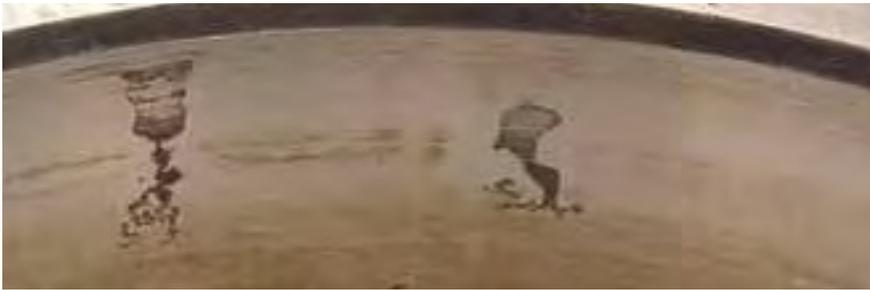
Figure 2: Showing etching

When it came time to write the report, I had all of the bearings cleaned for inspection and photographed. I quickly noticed there was more to this failure. I looked at the other bearing that did not fail and noticed some rather familiar and distinctive markings. There was evidence of both etching and fluting in almost a classic form.

Etching and fluting are classic results of stray currents arcing across the very small gap in the bearing.

The etching in Figure 2 is quite visible, however, when you run your finger along the bearing, it feels as smooth as the original ground metal.

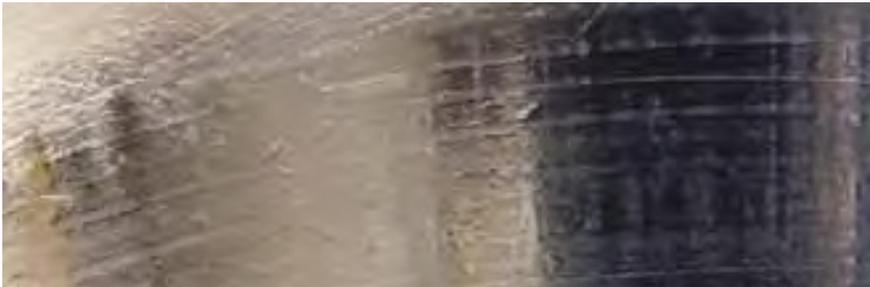
Figure 3: Showing vertical fluting

In Figure 3, the horizontal scratches, which were caused by metal-to-metal contact during the ultimate bearing failure, almost hide the underlying vertical flutes. The flutes were caused by the stray currents and the root cause of the failure.
