STRAY VOLTAGE OR STRAY CURRENTS

Jeff Johnson, ASL Roteq Ltd.

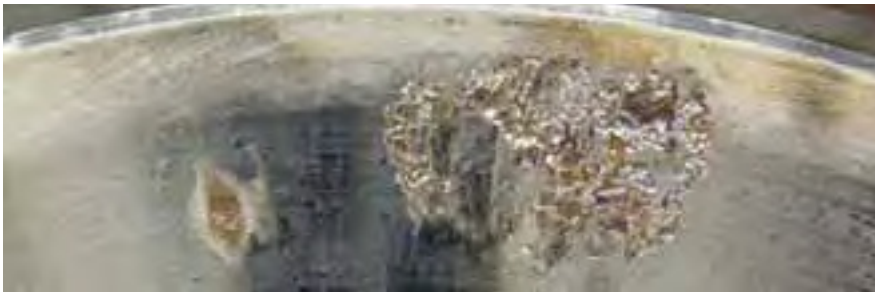
Figure 1: Damage caused by bearing failure

Several years ago, I was involved in a problem, occurring at the City of Peterborough WPCP, where a particular problem, occurring had experienced several failures over its short life. The pump was removed from site, brought back to our service centre, dismantled and inspected. The cause of failure was obviously the bearing, as shown in Figure 1.

The damage in Figure 1 appeared to be a typical bearing overload failure, which can be caused by lack of lubrication, overloading, or other typical mechanical problems. Everyone involved in the dismantle was confident this was the cause of failure. Due to the catastrophic nature of these types of failures, the root cause is often difficult to identify.

I suspect many failed bearings such as the one in Figure 1 are simply discarded and replaced. The pump or motor is put back into service with no knowledge of the root cause. If the pump fails every year, or two or three, it could easily be missed as a systemic problem. Without some form of failure analysis, the root cause of the problem may never be known.

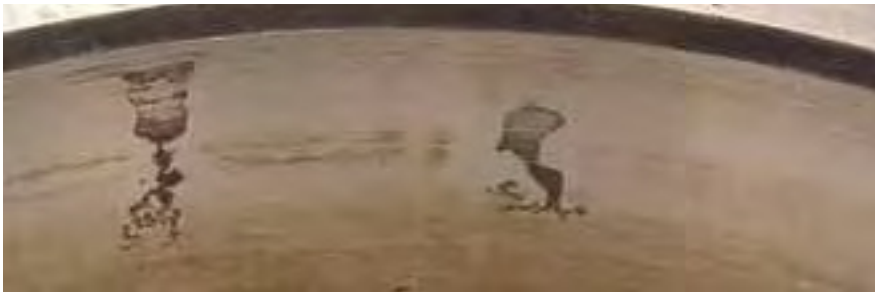
Figure 2: Showing etching

When it came time to write the report, I had all of the bearings cleaned for inspection and photographed. I quickly noticed there was more to this failure. I looked at the other bearing that did not fail and noticed some rather familiar and distinctive markings. There was evidence of both etching and fluting in almost a classic form.

Etching and fluting are classic results of stray currents arcing across the very small gap in the bearing.

The etching in Figure 2 is quite visible, however, when you run your finger along the bearing, it feels as smooth as the original ground metal.

Once the problem is identified, there are two basic solutions. The fundamental method of solving these problems is to prevent the currents from passing through the bearings. Current will always find the easiest and quickest path to ground.

One way to do this is to provide a ceramic coating on the motor bearing journals. The ceramic acts as an insulator and prevents the current passing from the shaft through the bearings. This is a common repair method for motors and is relatively inexpensive when compared to the cost of continual failure.

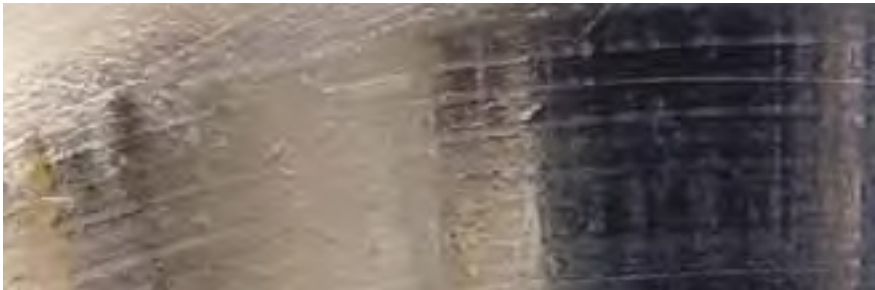
Figure 3: Showing vertical fluting

In Figure 3, the horizontal scratches, which were caused by metal-to-metal contact during the ultimate bearing failure, almost hide the underlying vertical flutes. The flutes were caused by the stray currents and the root cause of the failure.

To be absolutely certain of the diagnosis, I consulted a long-time colleague of mine from the Timken Bearing Company, who quickly confirmed my diagnosis. In fact, he commented that these parts could be the poster child for stray current damage patterns.

However, you must follow the path to be sure of the solution. In the case of a vertical line shaft pump and motor combination, the ceramic coating will protect the motor bearings, but the currents can still go down the line shaft and into the pump bearings.

The solution to this is to ground out these currents before the pump bearings. A shaft-grounding ring or brush can be installed relatively easily. The grounding ring or brush works very much like a DC

motor brush, where the current takes the easy path to ground, which is through this brush, thus preventing the currents from arcing across the pump bearings.
